Re: Notice of Violation  
National Pollutant Discharge Elimination System (NPDES) Permit No. TNG110041  
Memphis Ready Mix – Walker Ave Plant, 1280 Walker Avenue  
Memphis, Shelby County, Tennessee

**Compliance Inspection for Ready Mix Concrete Facilities General NPDES Permit**

<b>Facility Name:</b> Memphis Ready Mix Walker Avenue Plant	<b>NPDES Tracking Number:</b> TNG110041
<b>Facility Address:</b> 1280 Walker Ave, Memphis, TN 38106	
<b>Permit Coverage Effective Date:</b> November 14, 2017	<b>Permit Expiration Date:</b> October 31, 2022
<b>Date/Time of Inspection:</b> October 1, 2021, 0900-1030	<b>Inspectors:</b> Ginna McWhirter, Cliff Caudle
<b>Official Contact Person:</b> Mr. David Schwend, President	
<b>Address:</b> 1029 John A Denie Road, Memphis, TN 38134	<b>Phone Number:</b> 901-386-8911
	<b>Email:</b> David.Schwend@redemix.com

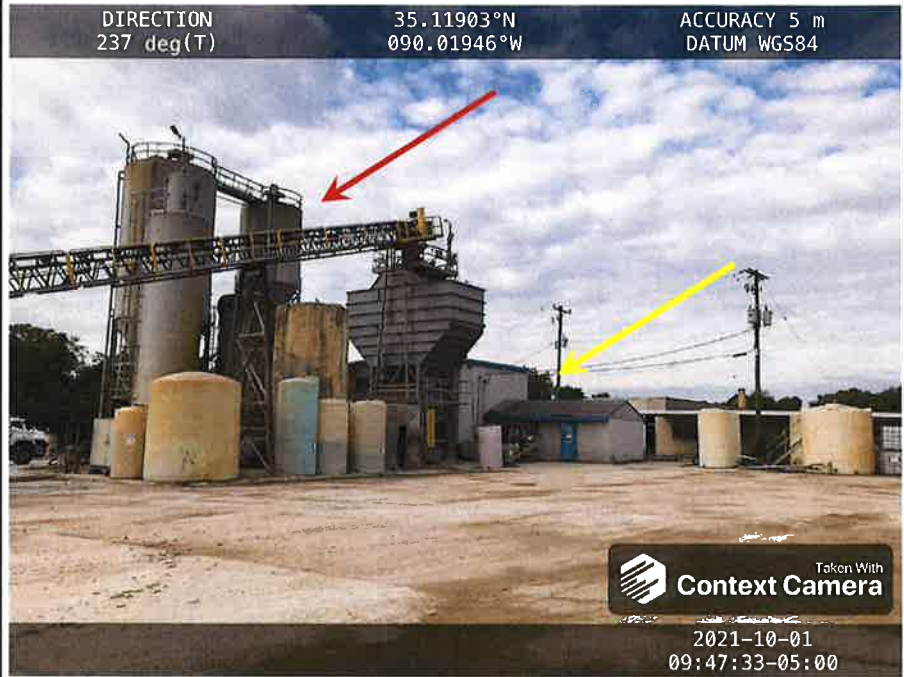
Photo No.	Photographer
1	Ginna McWhirter

**Description**  
View southwest of the batch plant (red arrow) and batch office (yellow arrow).

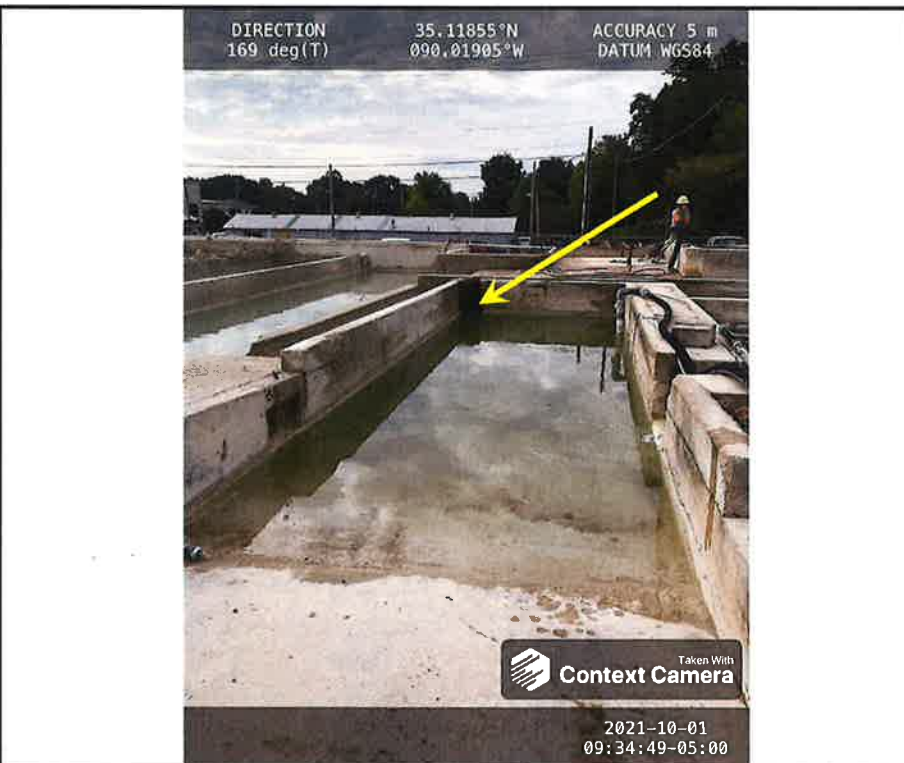
Photo No.	Photographer
2	Ginna McWhirter

On the south-central area of the facility, there is a seven-stage concrete treatment settling/retention basin on-site for its process water (Figure 1). According to Mr. Grow, concrete material in the basins was recently cleaned out. Water in the final basin appeared slightly turbid and colorless at the time of the inspection (Photo 2). Water from the final treatment basin was flowing steadily to the south to Outfall 001. The outfall pipe appeared to contain cementitious deposits. However, water appeared clear and colorless (Photo 3). It then flowed east to a storm drain (Photos 4 and 5), and ultimately flowed to Cane Creek via the storm drain. The concrete swale from the outfall to the storm drain appeared free of debris. However, at the east exit, some sediment was observed in a standing pool, but did not appear to be migrating from the pool (Photo 4). Cementitious deposits were observed at Outfall 001, throughout the concrete swale, as well as on the road adjacent to the swale (Photos 4 and 5). Some foam was noted in the storm drain from water falling into the storm drain. Hay was observed enclosing the outfall as a best management practice (BMP) (Photos 3 and 4).

**Description**  
View south of the final treatment basin. The pipe to the outfall is on the south side of the treatment basin area (yellow arrow indicates where the pipe to the outfall begins). Water appeared slightly turbid and colorless at the time the inspection.

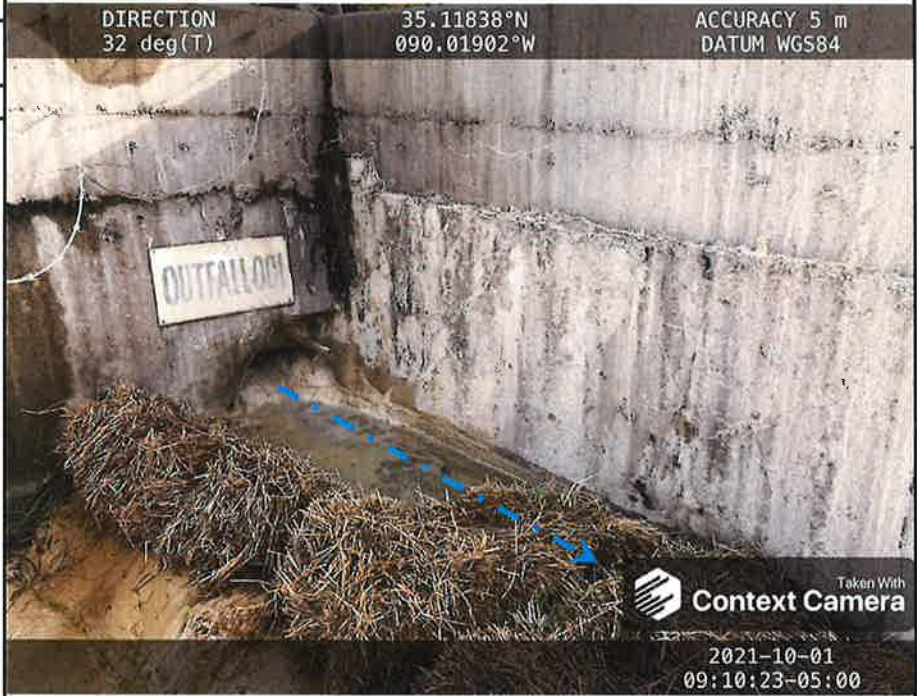
Photo No.	Photographer
3	Ginna McWhirter

**Description**  
View northeast of Outfall 001. The outfall pipe appeared to contain cementitious deposits. However, water appeared clear and colorless. Hay bales in place as BMPs. Flow is shown by blue dashed arrow.

3. To the maximum extent practicable, route all stormwater and process wastewater to the treatment basins before discharging off site.
4. Review on-site operations to reduce pH and TSS discharges to prevent future exceedances.
5. Cementitious deposits appeared around the outfall, the swale to the storm drain, as well as downgradient of the storm drain. Cementitious/sediment accumulation at the outfall and beyond is an indication that sediment/sediment-laden water is discharging from the site/outfall, off-site and into the stormdrain system (MS4). BMPs utilized on-site and management of the treatment basin should be reviewed and enhanced if necessary.

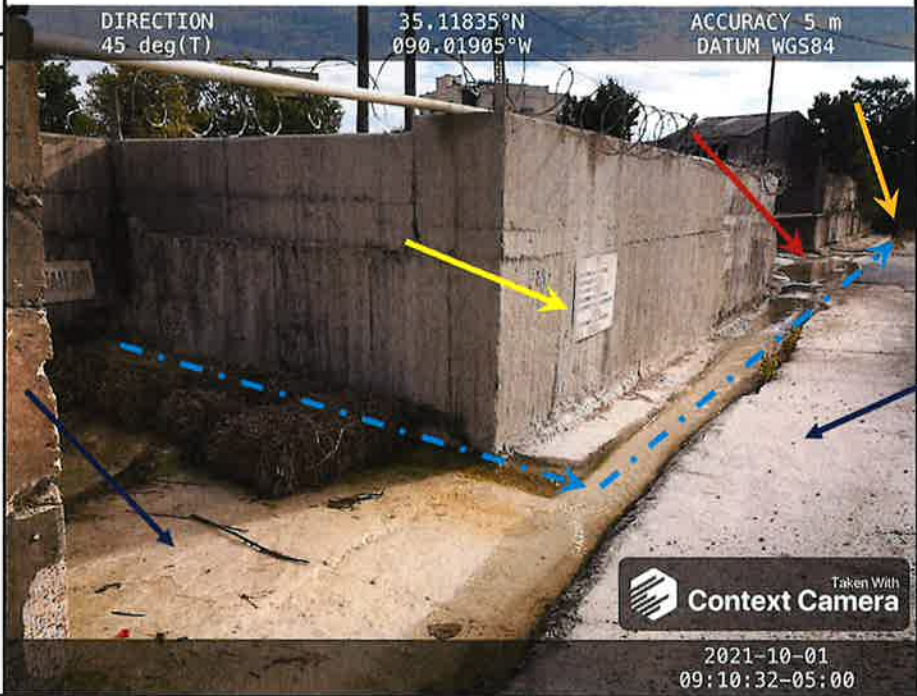
Photo No.	Photographer
4	Ginna McWhirter

**Description**  
View east of Outfall 001 and water flow to the storm drain. Cementitious deposits can be seen around the outfall, swale, and on the road adjacent to the swale (dark blue arrows). Flow is shown by the blue dashed arrow. The east exit where water pools and some sedimentation occurs is shown by the red arrow. The process water discharge sign is shown by the yellow arrow. The storm drain is shown by the orange arrow.

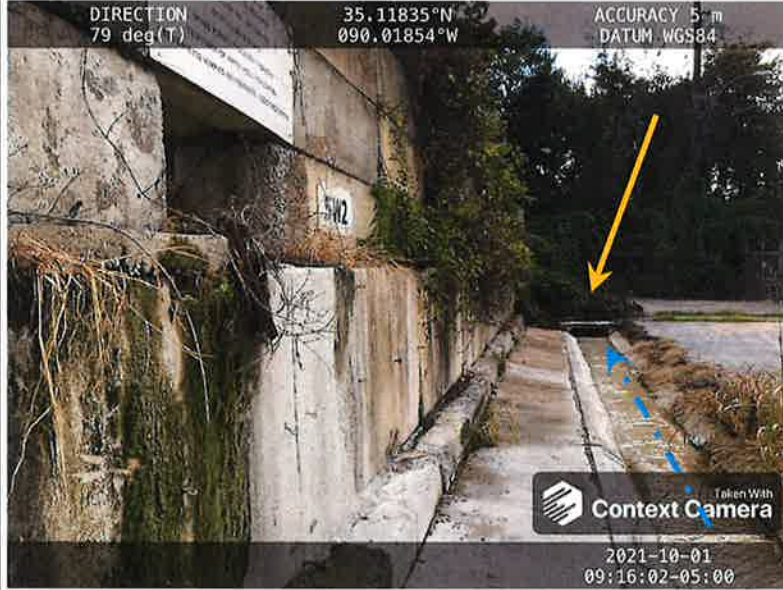
Photo No.	Photographer
5	GINNA McWhirter

East of the outfall, a sign labeled SW2 indicated where a previous outfall was located (Photo 5). It is no longer in use and is not a permitted outfall. This outfall appeared to have discharged stormwater from the eastern portion of the site at one point in time. Hay bales were observed in front of the outfall to assist with filtering the discharge.

**Description**  
View east of the storm drain (orange arrow) and SW2 sign. Water flow shown by blue dashed arrow.

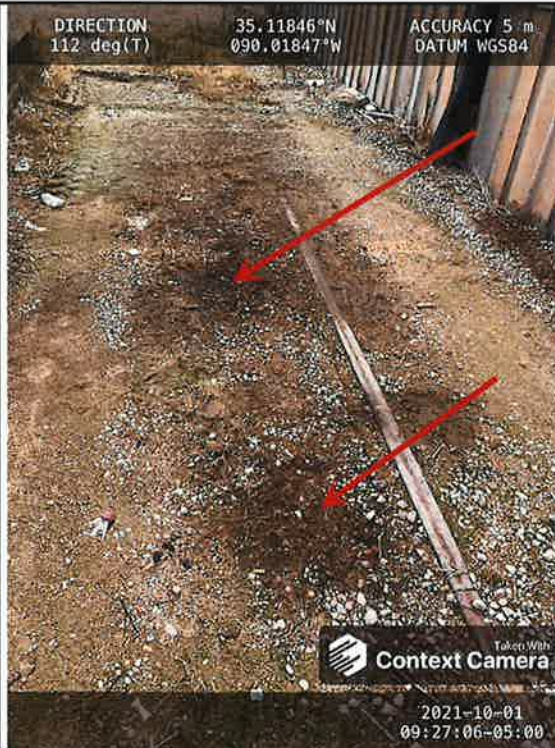
Photo No.	Photographer
6	GINNA McWhirter

A metal building was observed on the eastern portion of the site and contained hydraulic oil, antifreeze, and diesel exhaust fluid. No issues were observed, as the fluids were properly contained and under cover. Immediately northeast of the metal building, there is a large diesel tank which appeared to be in secondary containment. An oil-like substance was observed between the metal building and the diesel tank (Photo 6).

**Description**  
Oil substance observed on the ground between the metal building and the diesel fuel tank (red arrows).

1. Per the RMCP section 7.3.1. Good Housekeeping "Good housekeeping requires the maintenance of areas that may contribute pollutants to stormwater. Regular, frequent, and timely cleaning of leaks and spills prior to contact with stormwater are essential to controlling pollutants in stormwater discharges." There was evidence of spills and leaks in a couple locations. Per section 7.3.1., please ensure any leaks are addressed and any spills cleaned and properly disposed of.
2. Using Best Management Practices (BMPs), ensure any barrels or admixture tanks are closed to prevent exposure to stormwater.

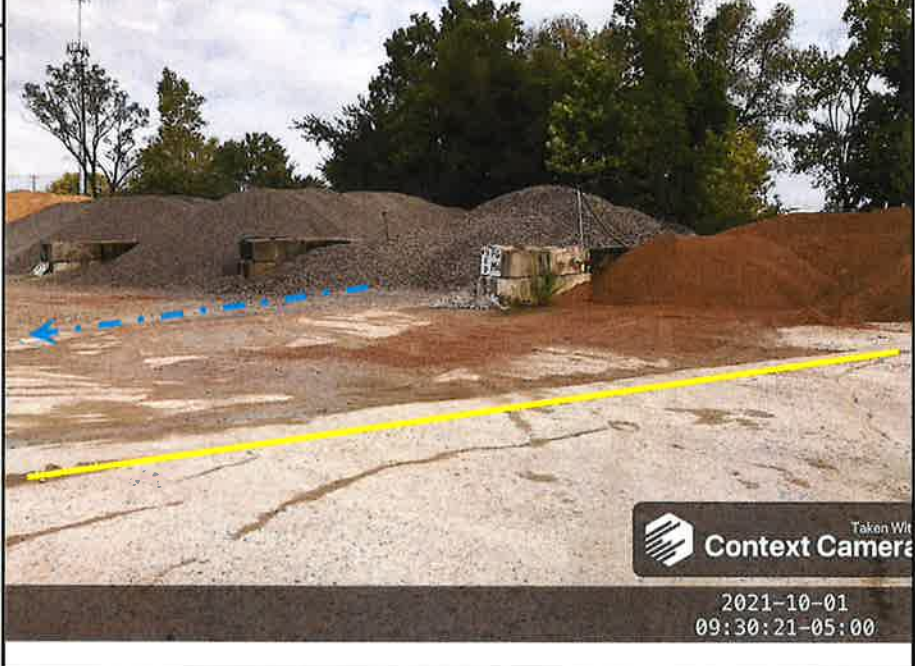
Photo No.	Photographer
7	Ginna McWhirter

The northern perimeter of the site contained aggregates that were being sprayed with water. A small, concrete diversion berm was placed to direct water to the treatment basins. The aggregate was contained within concrete block walls. Concrete and sediment were noted on the ground between the aggregate piles and the basins, but all water from this area appeared to drain to the basins (Photo 7).

**Description**  
View northwest of the aggregates. A small concrete berm (yellow line) directs water (blue dashed arrow) to the treatment basins.

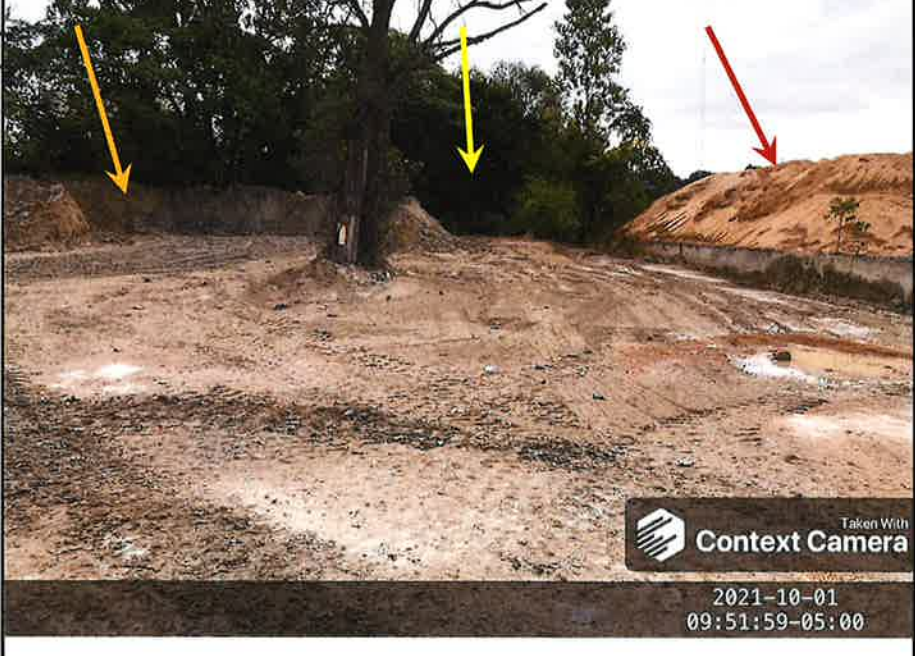
Photo No.	Photographer
8	Ginna McWhirter

The berm north of the recycled concrete area appeared maintained. A defunct large metal barrel was observed on its side to the southeast of the recycled concrete (Photo 8). According to Mr. Walker, an agreement between the northeast adjacent property owner and MRM allows them to use this area for recycled concrete.

**Description**  
View southeast of the recycled concrete area (orange arrow). Aggregates are to the southeast of this area (red arrow). The defunct barrel is shown by the yellow arrow).

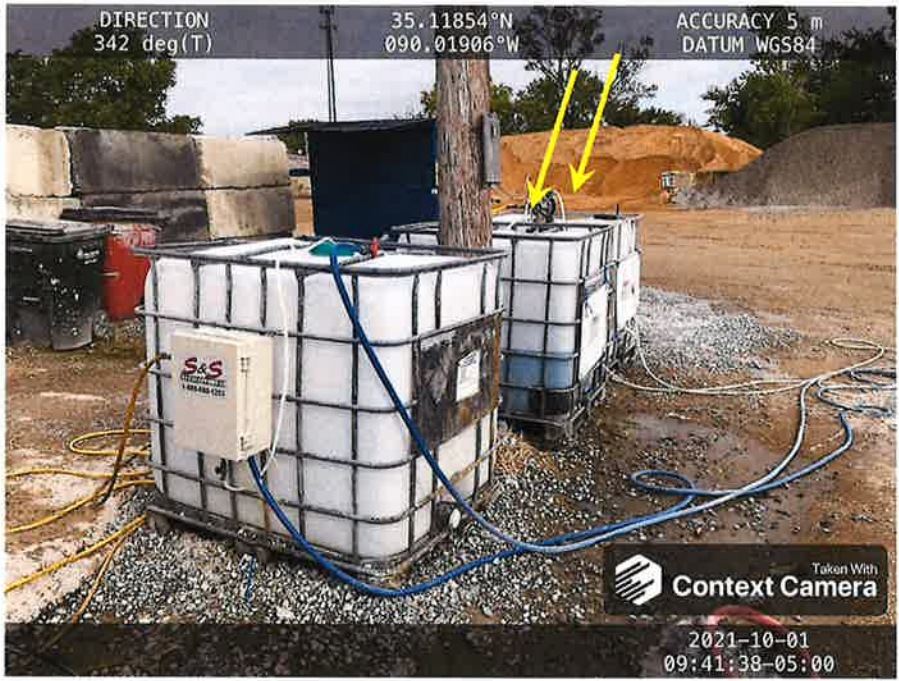
Photo No.	Photographer
9	Ginna McWhirter

Near the basins, a couple tanks with truck cleaning fluid were not properly closed (Photo 9).

**Description**  
View north of truck cleaning product. The two tanks furthest away did not have lids (yellow arrows).

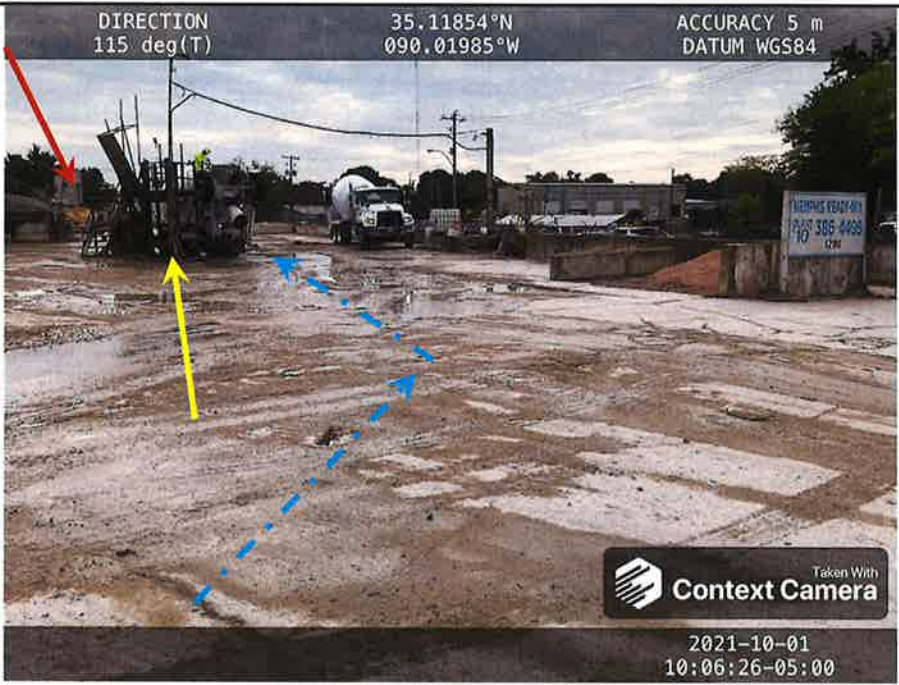
Photo No.	Photographer
10	Ginna McWhirter

The wash rack, located to the southeast of the batch plant and west of the basins, is used to clean the trucks and wash out the truck drums. Water from the wash rack appeared to drain to the basins (Photo 10).

**Description**  
View southeast of the truck wash (yellow arrow). Water is directed to the treatment basins located southeast of the truck wash (not observable in photo but the location is demonstrated by the red arrow). The western entrance is to the right in the photo. Water flow is shown by blue dashed arrow.

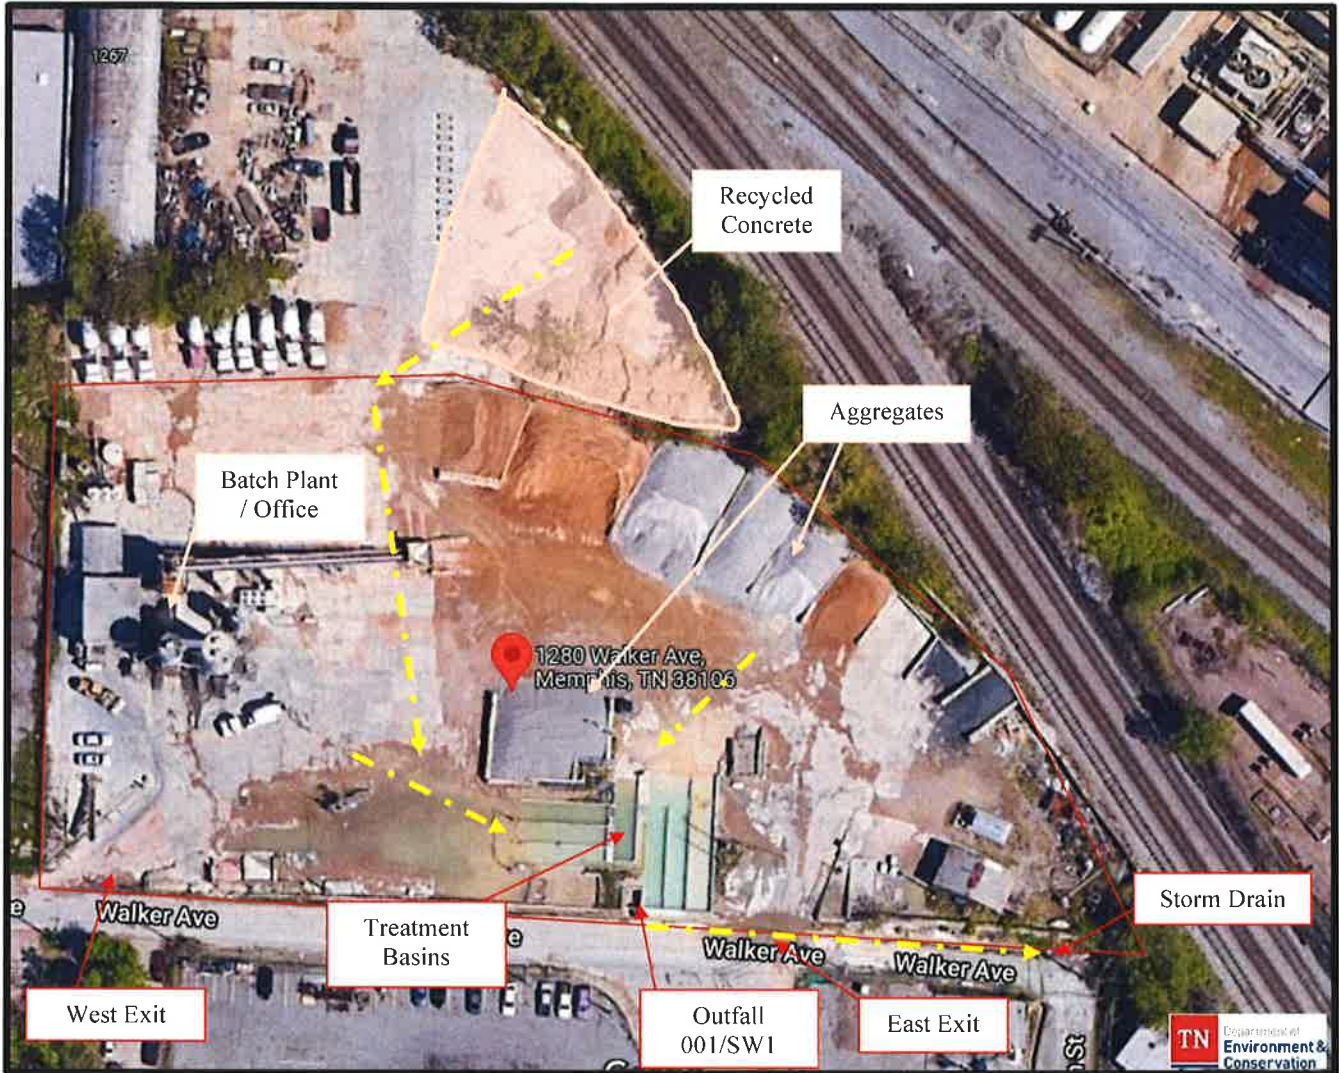
**Figure 1: Site Layout**

The MRM Walker Plant was in operation at the time of the inspection. MRM Walker Plant operates a concrete batch plant and batch office at the facility (Photo 1). Figure 1 is attached and shows an overall aerial view of the site and the designated outfall.
